Review

Review of Current Guided Wave Ultrasonic Testing (GWUT) Limitations and Future Directions

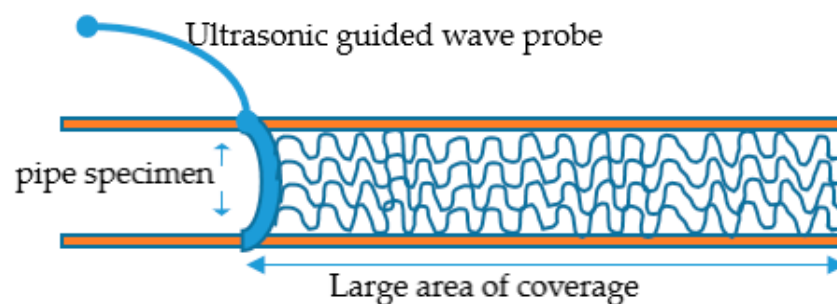
Figure 1. Difference between (a) ultrasonic testing, UT; and (b) guided wave ultrasonic testing, GWUT.

The conventional ultrasonic testing (UT) whose frequency is dependent on the thickness of the inspecting structure is different from GWUT of frequency range 20 kHz through 15 MHz or more in rare cases [12,13]. The UT is a high-frequency pulse-echo inspection technique for deep penetration into structural thickness [14]. It covers a limited area of the structure, unlike the GWUT that propagates a long-distance structure, as shown in Figure 1a,b.

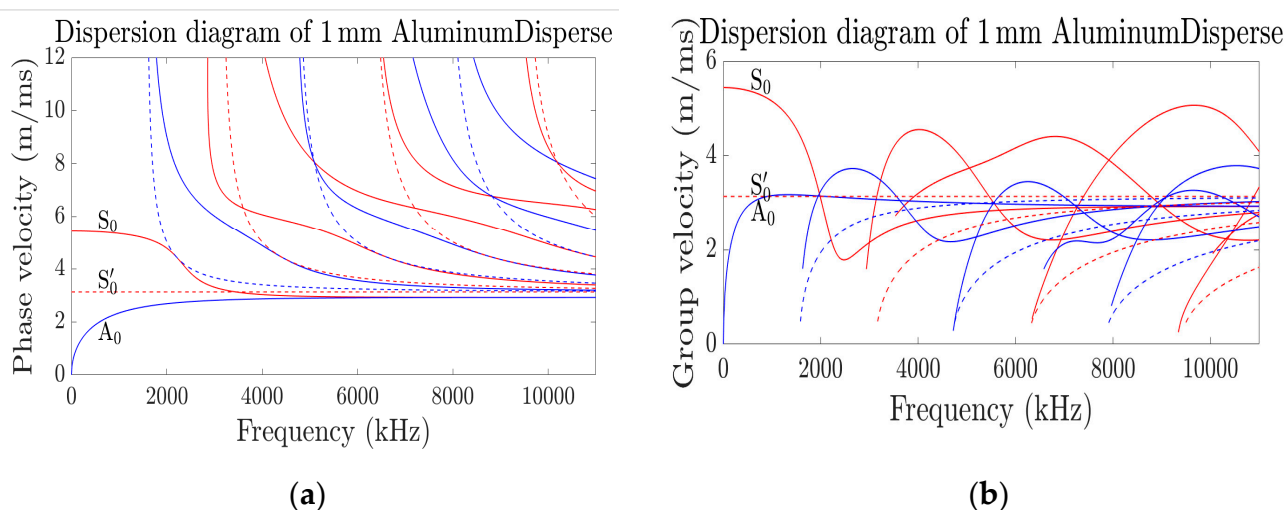
Figure 2. (a,b) Dispersive curve of 1 mm thickness of Al obtained using DC [77].

modes. Therefore, it is suitable to monitor the health condition of the plate using S_0 mode as the generated excitation signal. However, excitability and sensitivity of the modes, especially with regards to thickness reduction due to corrosion was not accounted for. In [73], an optimized dispersion curve that relies on the excitability and sensitivity in addition to the group velocity of the mode was developed. This was named goodness dispersion curve, and it offers an informed mode suitable for damage detection but limited to material thickness reduction due to general corrosion. It was revealed that sensitivity of guided wave varies with wave frequency and at low frequency, the wave is insensitive to small thickness variation of the metal. Interestingly, the fundamental symmetric, S_0 , and asymmetric, A_0 , modes were recorded as insensitive.

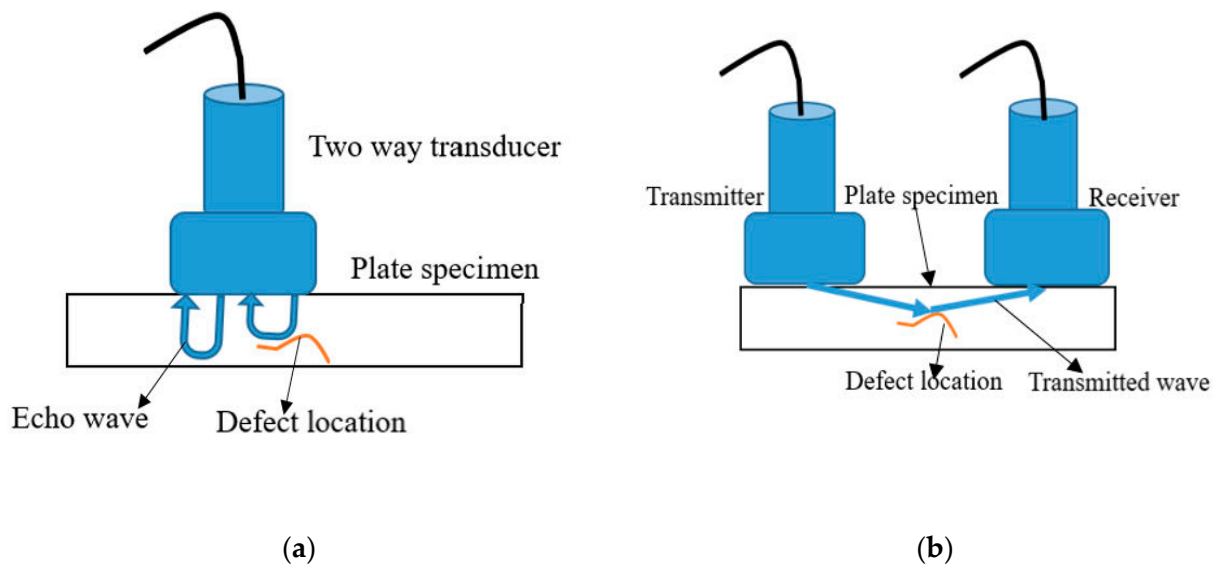
Figure 4. (a) Pulse–echo method with a transducer; (b) Pitch–catch method with two transducers (R) [86].

The configuration topology of the transducer is majorly either pulse-echo (P-E) or pitch-catch (P-C) depending on the geometry of the inspecting structure, targeted defect of interest and the needed data [34]. The typical examples of the methods are shown in Figure 4. In P-E, a single or two transducer(s) is used, and the reflected echo signal, time-of-flight (ToF) alongside the propagation velocity are used to determine defect, deterioration, discontinuity, or thickness of the material structure [70,85]. A minimum of two transducers is required in P-C and spaced sufficiently to generate defect interrogating wave and receive it after interrogation with the structural defect. This configuration is often applied to detect

or monitor defects that are not sufficient to cause reflection somewhat further transmission of the wave though attenuated. Unlike the P–E method, the P–C measurement is the amplitude of the damage signal or the received damage signal's shape. P–C is an excellent choice to make when the intention is to cover a long-range structure [86].

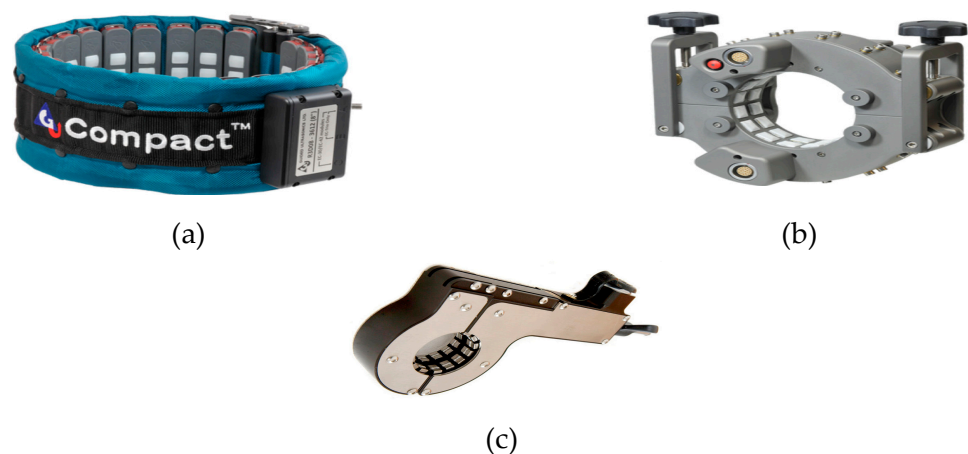
Figure 5. (a) Compact ring transducer; (b) Solid ring transducer; (c) Claw transducer [87].

In pipeline inspection, piezoelectric transducers are distributed and interconnected in parallel to form a ring of an array around the pipeline's circumference [44–46]. This technique of inspecting the pipeline is devoid of surface preparation unlike other types of inspecting technique; hence, saves time and encourages more length inspection in a day. However, hopping the device from one point to another is laborious, coupled with its weight, installation, and uninstallation time at distances of interest. Some of the available collar ring transducers in the market for a specific inspection challenge are shown in Figure 5. The compact ring is designed for a wide range of inspection with a 30–35% weight reduction. The solid ring transducer type is for standard inspection of 2–8 inches pipes while the claw transducer type is designed to inspect a closely spaced pipeline that cannot allow the fitting of the conventional ring [87]. A typical transducer ring array contains 2–24 transducers depending on the diameter of the pipe [28,88,89].

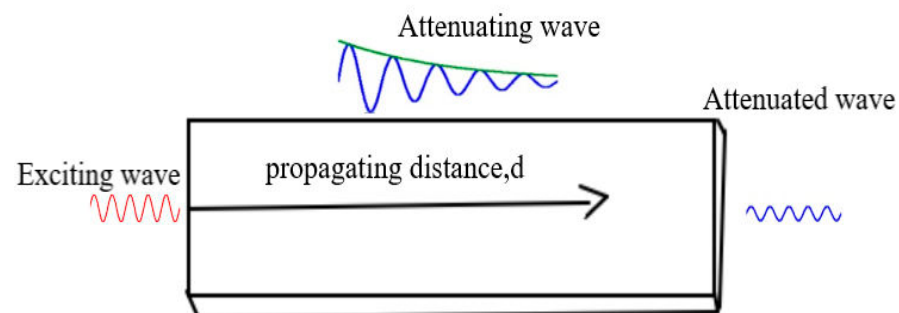
Figure 7. Signal attenuation in a medium.

Attenuation reduces signal level, either in amplitude or energy as it propagates through a medium [81]. Figure 7 is a typical demonstration of wave attenuation in a medium. The diminishing of the propagating signal amplitude often follows an exponential decay pattern expressed in Equation (13) while variation in the signal intensity is described in Equation (14).

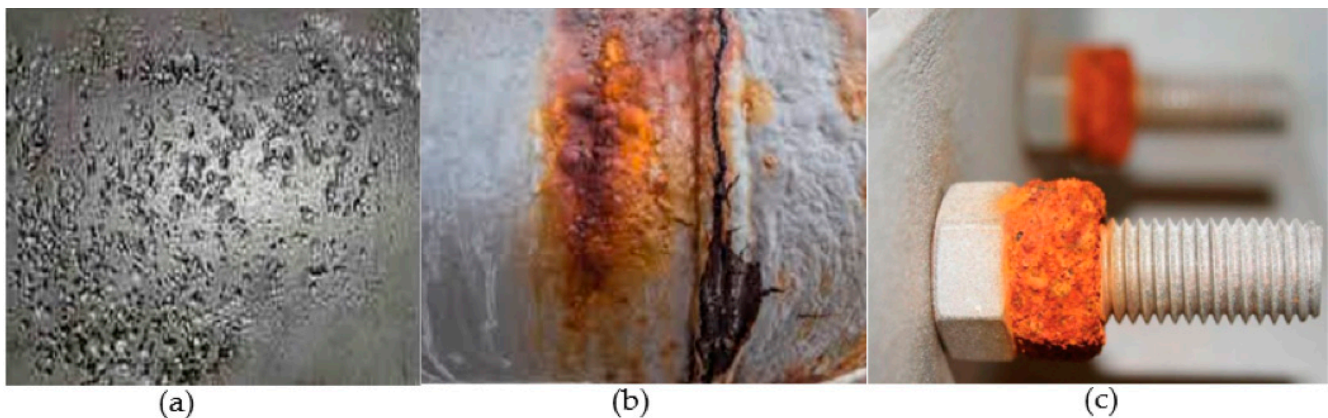
Figure 8. (a) Pitting corrosion in carbon steel [109]; (b) stress crack corrosion on carbon steel [110]; (c) crevice corrosion on a bolt [111].

Corrosion activity is an inevitable effect on metallic structures. It is one of the significant issues of safety in industries and results in corrosion failure of structures. It is instigated mostly through metal interaction with immediate environmental variables (oxygen in the air, hydrogen, chlorine, ambient temperature, humidity, and presence of microbial) or stress on the metallic structure as in the case of stress corrosion cracking [102–104]. The result of corrosion activity would be reddish rust if it happened in the presence of oxygen or greenish rust in the chlorine-dominated environment [105,106]. Some corrosion forms are pitting, crevice, and stress corrosion cracking with their peculiarities [107,108] as shown in Figure 8.

The pitting corrosion is caused by unevenness in the metal structure or breakdown of the metal surface's protective coating, thereby exposing it to electron loss. It is not easy to predict and detect. Hence, it has the capability of causing corrosion failure and remain undetected. Crevice corrosion occurs due to an imbalance in ion concentration between the activity areas of the metal structure. It could happen in an oxygen-limited area such as under washers or bolts [111]. The growth of crack on ductile metal due to corrosive surroundings and applied cyclic stress is referred to as stress corrosion cracking (SCC) [112]. Corrosion rate on the material is estimated using Faraday's law [113] of metal's electrochemical reaction as in Equation (16).

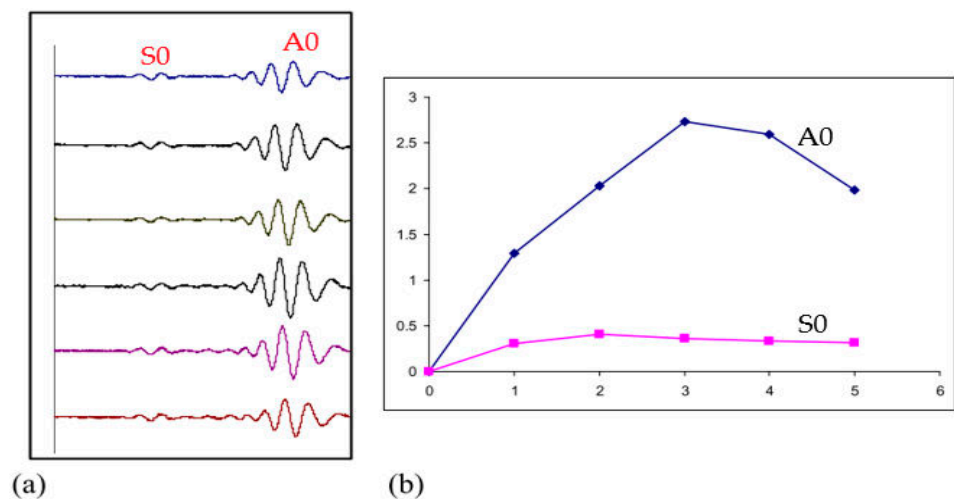
Figure 9. DI analysis on pitch-catch signals for corrosion detection. (a) Received signal at PWAS 4 when PWAS 0 sent at 120 kHz; (b) DI curves of both A_0 and S_0 wave packets at 120 kHz of path 0-4 [117].

High-frequency GWUT has been extensively used in monitoring corrosion activity in structures [63,114,115] although low-frequency monitoring was demonstrated in [116] using 64 PZT sensors. In [117], Victor Giurgiutiu et al. leveraged on piezoelectric wafer active sensor (PWAS's) cheap cost, and networked multiples of it for corrosion detection and localization in plates and pipelines. Fundamental lamb wave modes S_0 and A_0 at high frequency (120 KHz) were generated and used. It was revealed that A_0 is more sensitive than S_0 in detecting corrosion both in plate and pipe although S_0 travels faster but less sensitive to the metal thickness changes. This is depicted in Figure 9.

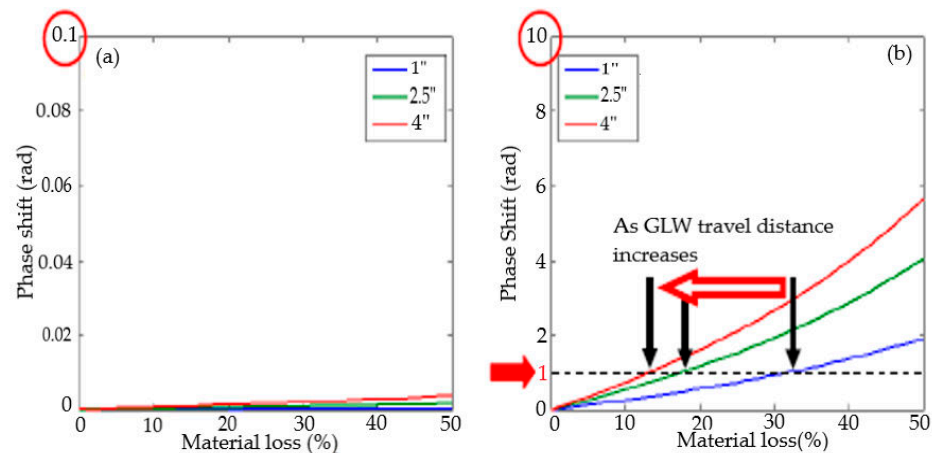
Figure 10. Phase shift estimation according to three-wave propagation distance (60 kHz excitation) (a) S0 mode (b) A0 mode of GLWAdpted with permission from [59]. Copyright 2012, ASME.

In [118], accelerated corrosion activity on a steel bar in concrete was successfully monitored using high frequency (200 KHz) lamb wave. The study revealed that corrosion in this nature could be detected using the FFT signal's amplitude response. In [59], corrosion activity was experimentally monitored and quantified using a damage index profile map and A_0 phase shift of the sensor signal. The A_0 group velocity was observed to vary accordingly with the material loss from 0–50% of the thickness. The obtained result suggested that the phase shift of the fundamental antisymmetrical lamb wave A_0 mode can be used to quantify early corrosion activity in structures, as shown in Figure 10.

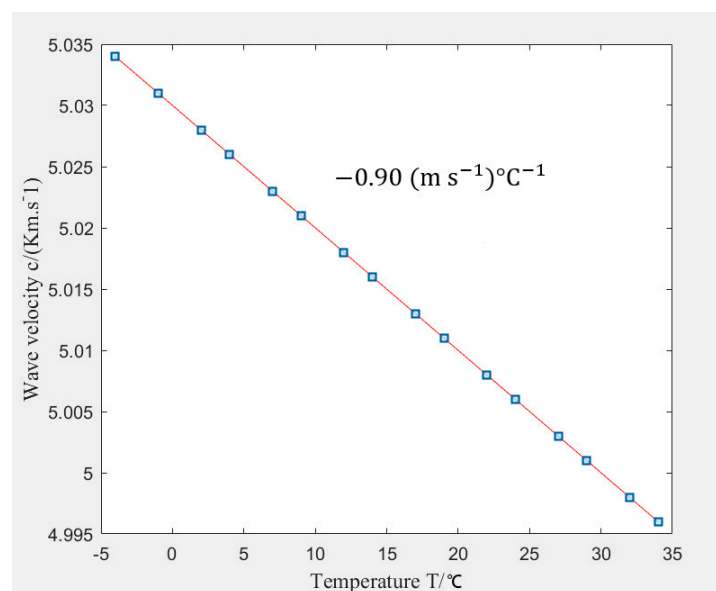
Figure 11. Temperature effect on Lamb wave velocity (R) [124].

Environmental factors vary uncontrollably and interact with installed asset structures. This interaction results in guided wave parameter variation, especially during thermal expansivity [122]. Since metallic structures are an excellent medium for propagating the inspecting wave and serve as host for the sensors, the effect of environmental variation on the metal could be transferred on the sensor directly or indirectly hence causing variation in the parametric features of the sensor signals. These variations mostly result in masking damage signals, thereby allowing failure to occur. Studies have been carried out to investigate the ambient temperature variation on the ultrasonic guided wave (host) and the transducers (actuator and sensor). In [123], Cawley made a comparison study of crack formation effect on the resonant frequency and impact of the beam's length on the resonant frequency. The result showed that the change caused by 2% depth cut of the crack was 40 times smaller than that caused by a 2% increase in the beam's length. The effect of temperature on UGW has been widely studied. In [124], Lui Zenghua et al. investigated the effect of temperature ($-4\text{ }^{\circ}\text{C}$ to $34\text{ }^{\circ}\text{C}$) on lamb wave, L (0,1) propagating on steel. The wave velocity was reported to vary inversely to increase in temperature, as shown in Figure 11. The retardation rate of the velocity was recorded to be 0.9 m/s for every degree of increase in temperature.

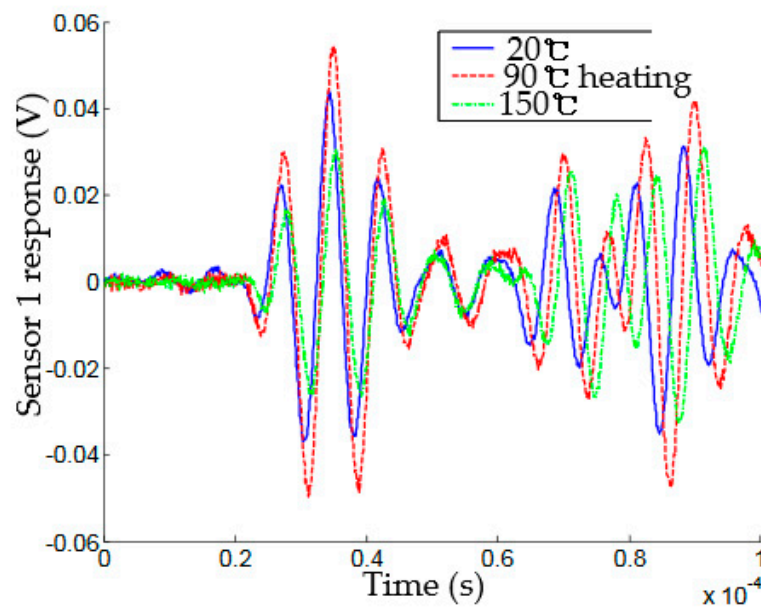
Figure 12. Temperature effect on PZT amplitude [126].

The study on anisotropic plate material carried out by Lanza et al. witnessed similar behaviour but on the wave signal amplitude [3]. It was observed that the wave amplitude increases at the temperature below $20\text{ }^{\circ}\text{C}$ and decreases at a temperature above $20\text{ }^{\circ}\text{C}$. This effect is suggested to be attributed to the competing roles of the PZT coefficients and the dielectric permittivity. When the parameters were isolated, the amplitude response to temperature variation was observed to be proportional. Similar proportionality response was observed when the high-temperature transducer array coupled in an empty pipeline was subjected to a temperature of $7\text{--}150\text{ }^{\circ}\text{C}$ [125]. In the pitch-catch study of varying temperature ($20\text{--}150\text{ }^{\circ}\text{C}$) effect on guided wave performed by Raghavan and Cesnik in [126], the response was observed to be nonmonotonic in the measured amplitude as shown in Figure 12. The amplitude response signal increased when the temperature is $20\text{--}90\text{ }^{\circ}\text{C}$ but decreased when it is $90\text{--}150\text{ }^{\circ}\text{C}$. This behaviour was subjected to further theoretical and experimental studies. Its behaviour was attributed to the assumption of perfect bonding and constant adhesive layer properties through the temperature range.

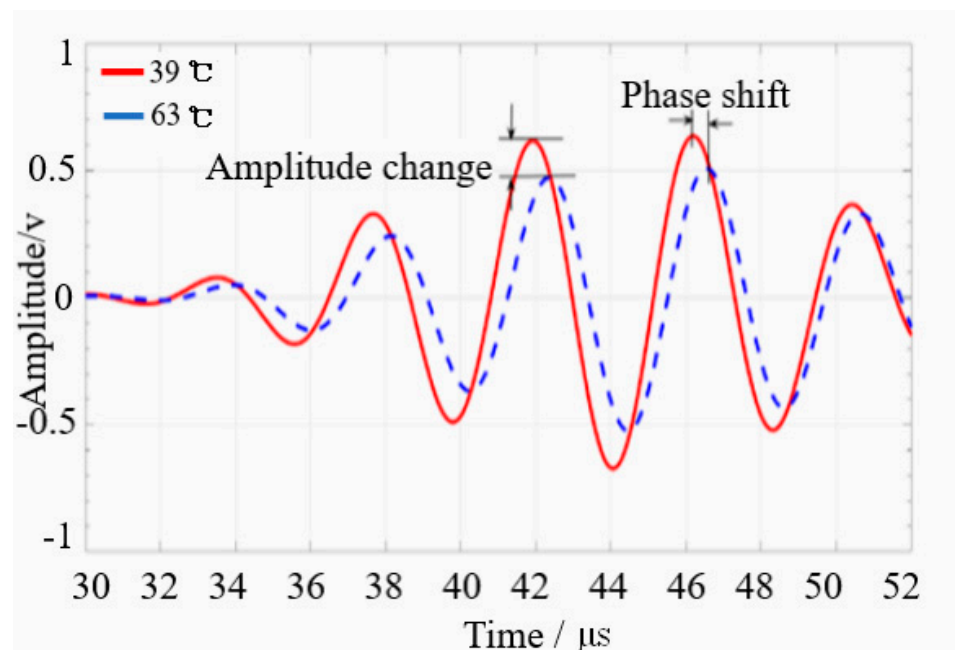
Figure 13. Typical signal differences under different temperatures [5].

Some other research studies on temperature influence on a guided wave and wave inspection parameters can be read in [6–10,129–131]. Figure 13 showed the significant effect of temperature variation that resulted in amplitude distortion and signal phase shift [5].

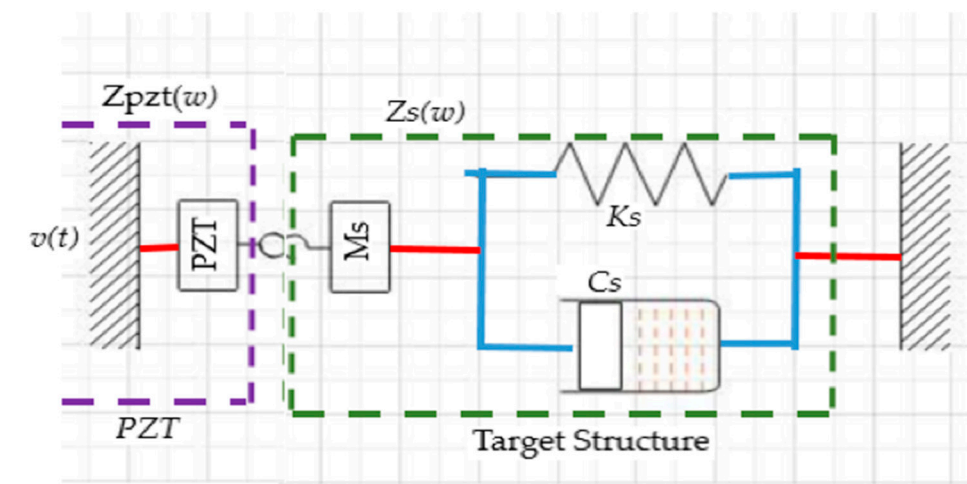
Figure 14. 1-D PZT–target structure interface [143].

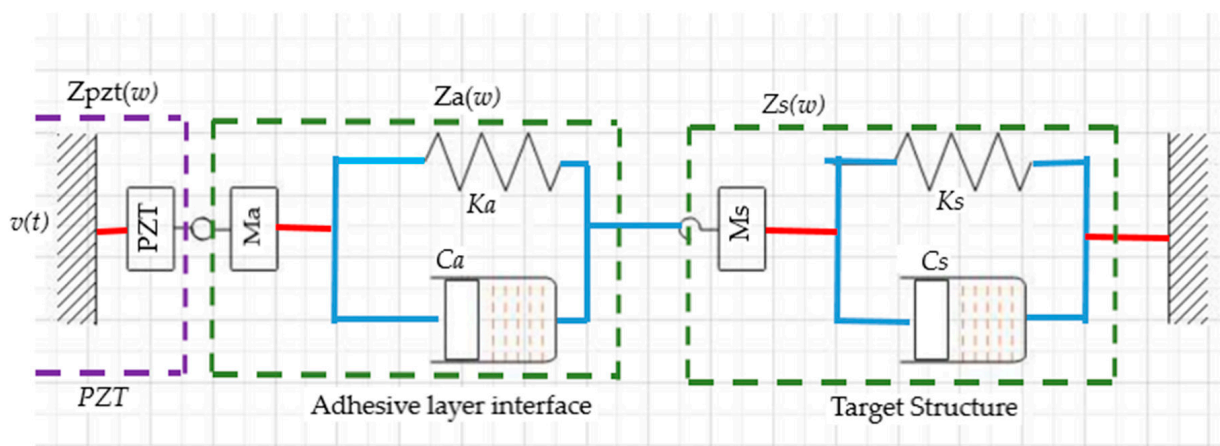
**Figure 15.** Modified PZT–host structure interface [142].

In this model, the output characteristics of PZT is determined via its dynamic properties and structural impedance. By varying the stiffness of the model depicts changes in the target structure.
